# Property Inspection Report

## Zenith Property Inspections

## Inspection Address

Dublin, CA 94568

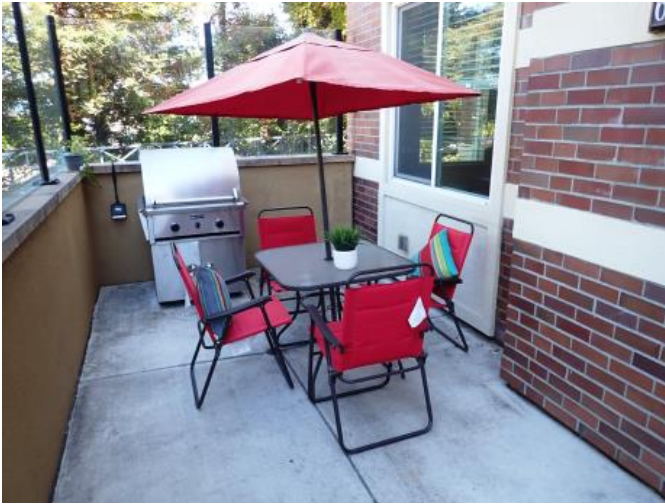
Front entrance appeared serviceable

View of front patio

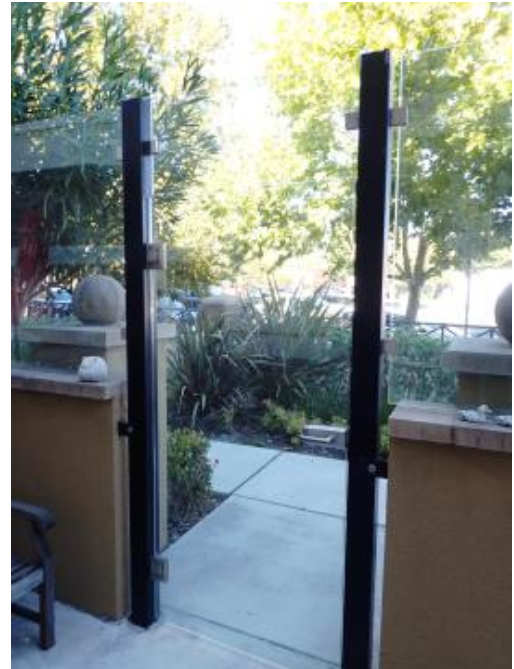
Glassdoor and glass walled front entrance viewed from inside

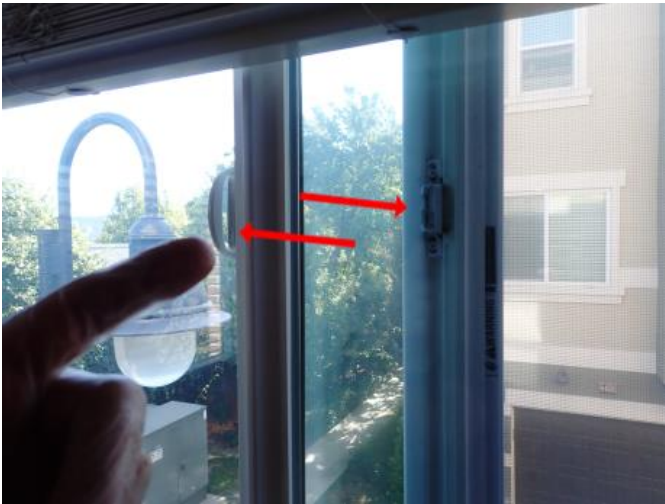
The window on the back wall in the dining room does not latch when closed. The upstairs back right top window appears to possibly have a broken seal between the double pane. Recommend qualified contractor or proper person evaluate these windows for any repairs that may be needed.

The back dining room window does not latch when closed

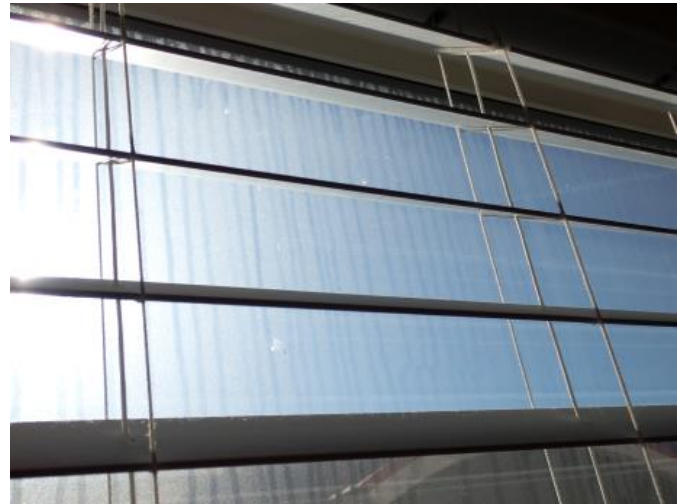
The back right upper bedroom window appears to possibly have a broken seal between the two panes..

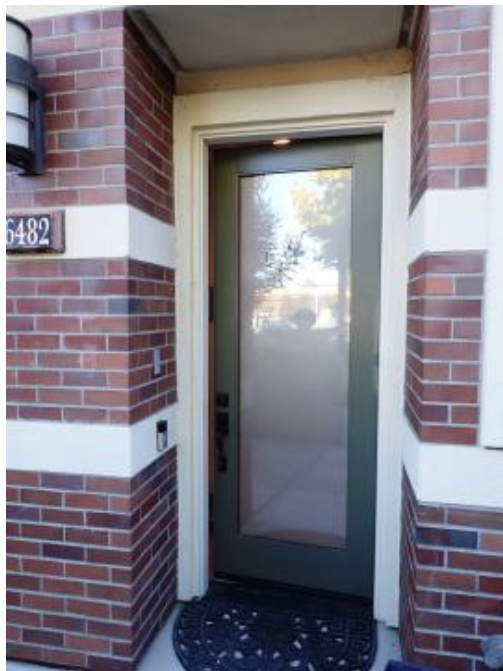
Front door appeared serviceable

Front door entrance appeared serviceable

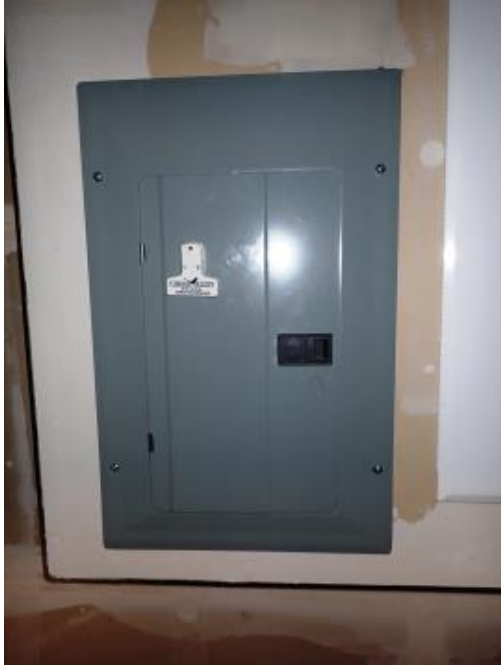
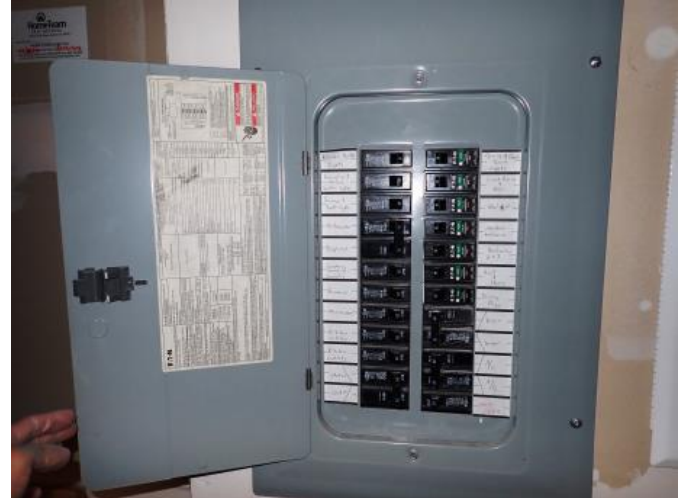
All breakers appeared serviceable with labels

Subpanel located on the back wall of the garage

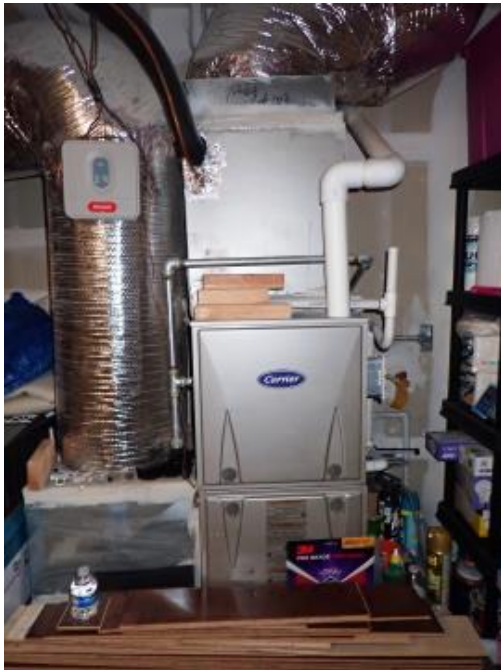
The heating system was operational. This is not an indication of future operation or condition. Manufacturer label shows build date of 2012.

The furnace appeared serviceable

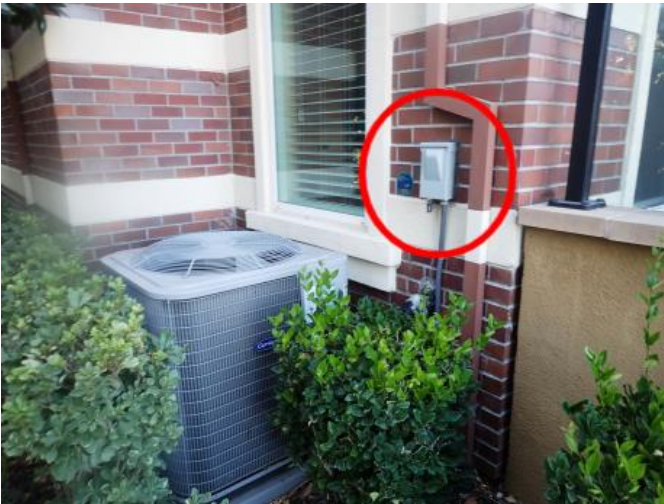
The AC unit is located on the exterior front left corner of the building. Manufacturer label shows a build date of 2012. AC tested operable

AC unit front left exterior of the townhome. Master shut off on wall behind

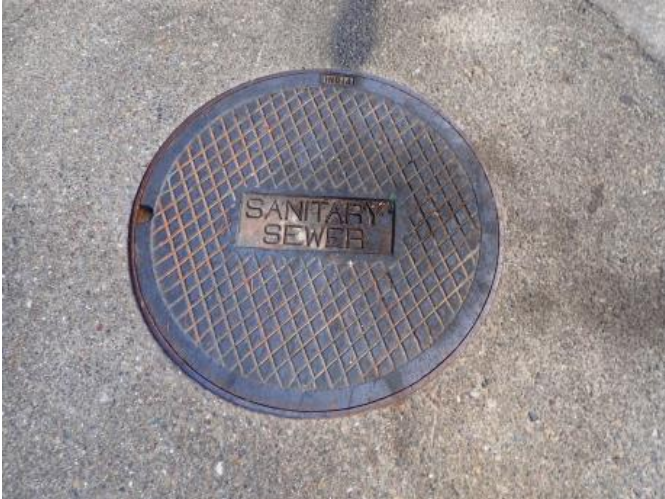
The main sewer line for the building is located in the shared driveway

The main sewer cleanout for the building is located in the shared driveway

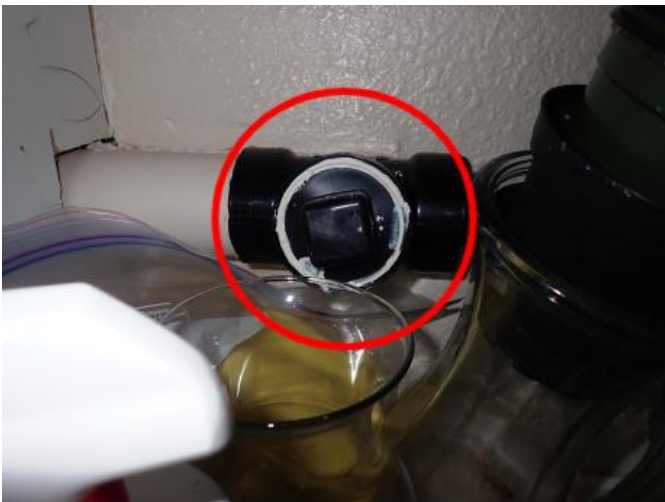
The main house cleanout appears to be under the kitchen sink

The main house cleanout is under the kitchen sink on the left

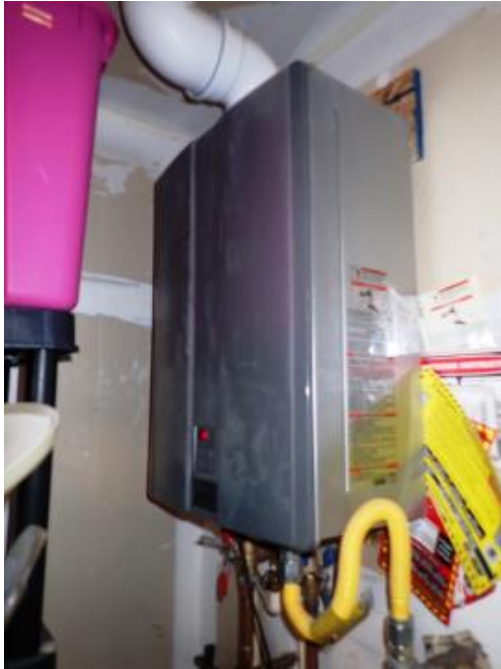
The water heater was operable at the time of inspection. This does not however guarantee future performance, operation, or condition.

Tankless water heater located front right corner of garage

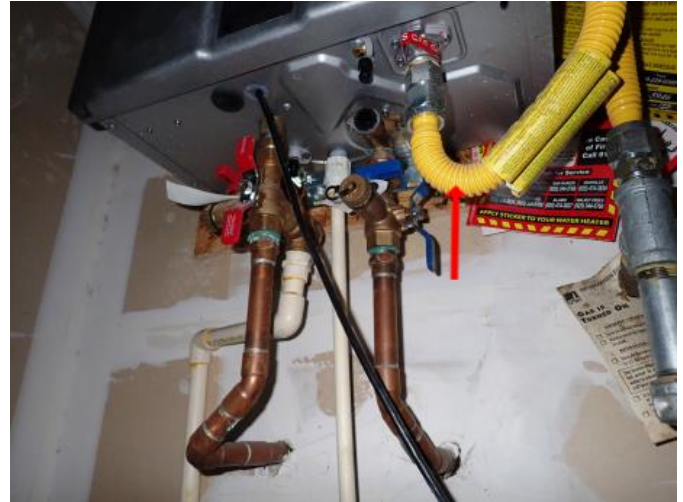
All water and gas shut offs are located below the unit.  
Gas shut off is the yellow line

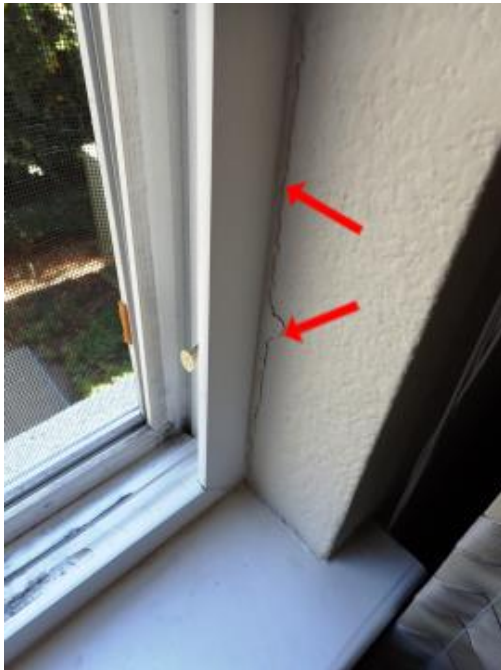
All walls and ceilings appeared serviceable. On the main level sidewall window frame, there were visible common cracks along the sides of the window. These can be sealed and painted.

Small common cracks like these around the windows can be sealed and painted

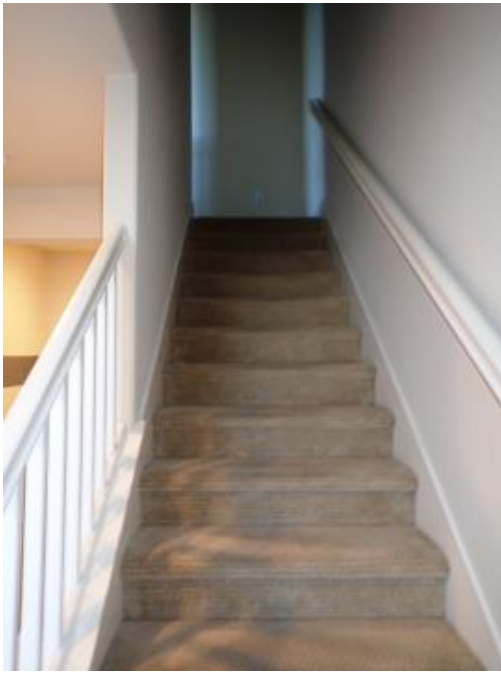
All stairs, balusters, and handrails appeared serviceable

View of first set of stairs with balusters and handrail on the left and right sides

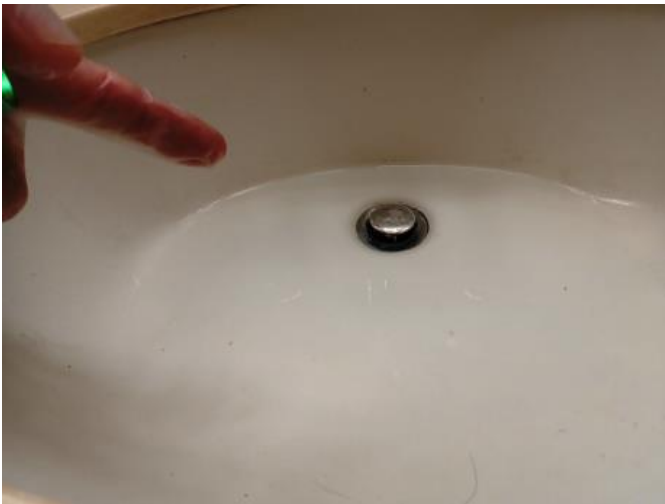
Sink faucets and under sink plumbing tested operable. No visible leaks. The right sink drained slowly when filled and drain. Recommendation would be to use an over-the-counter drain cleaner to see if that clears the slow drain. If not, recommendation would be to have a qualified plumber evaluate to determine clog and clear it.

The right sink in the primary bathroom drains very slowly.

Sink & Cabinet Conditions	8.9	Sink faucets and under sink plumbing tested operable. No visible leaks. The right sink drained slowly when filled and drain. Recommendation would be to use an over-the-counter drain cleaner to see if that clears the slow drain. If not, recommendation would be to have a qualified plumber evaluate to determine clog and clear it.
Toilet Conditions	8.12	The toilet flushed but did not refill. Recommend proper person evaluate to determine cause and any repair if needed. The water appeared to be on but the toilet did not refill.
<b>Bathrooms (non- primary)</b>		
Counter - Type and Condition	9.9	Single vanities with hardtop counters in all bathrooms. All appeared serviceable. The left edge of the countertop in the hallway bathroom upstairs showed visible common cracks in the caulking. Recommend resealing to eliminate any possible water penetration. This should be an easy fix

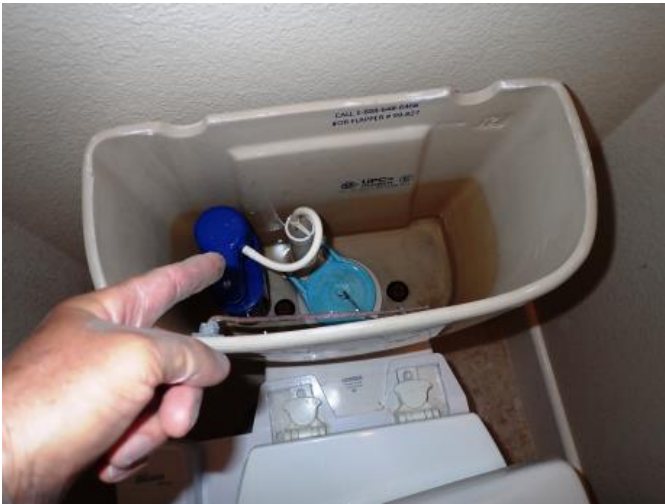
The toilet flushed but did not refill. Recommend proper person evaluate to determine cause and any repair if needed. The water appeared to be on but the toilet did not refill.

The primary bathroom toilet did not refill when flushed.  
Needs further evaluation

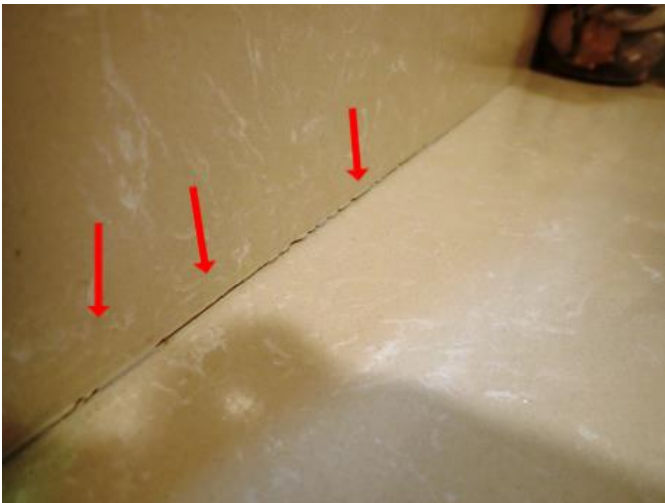
Single vanities with hardtop counters in all bathrooms. All appeared serviceable. The left edge of the countertop in the hallway bathroom upstairs showed visible common cracks in the caulking. Recommend resealing to eliminate any possible water penetration. This should be an easy fix

Common cracks in the grouting along the left side of the hallway bathroom sink upstairs. Should be resealed all the way around

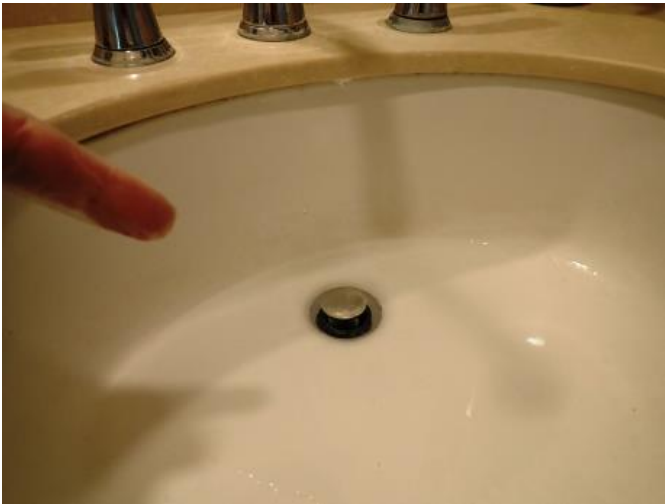
All sink faucets and under sink plumbing tested operable, no visible leaks. The half bath on the main level, the sink drained slowly. Recommendation would be to use an over-the-counter drain cleaner to see if that clears the slow drain. If not recommendation would be to have a qualified plumber evaluate for any repairs necessary to provide efficient water flow.

The main level half bathroom sink drains very slowly.

Sink & Cabinet Conditions	9.10	All sink faucets and under sink plumbing tested operable, no visible leaks. The half bath on the main level, the sink drained slowly. Recommendation would be to use an over-the-counter drain cleaner to see if that clears the slow drain. If not recommendation would be to have a qualified plumber evaluate for any repairs necessary to provide efficient water flow.
<b>Kitchen and Appliances</b>		
Possible Rodent Activity	10.9	There appeared to be some evidence of possible rodent activity under the kitchen sink and in the pantry. Recommend qualified contractor or proper person evaluate to determine if this is current or past and provide any remediation if needed.

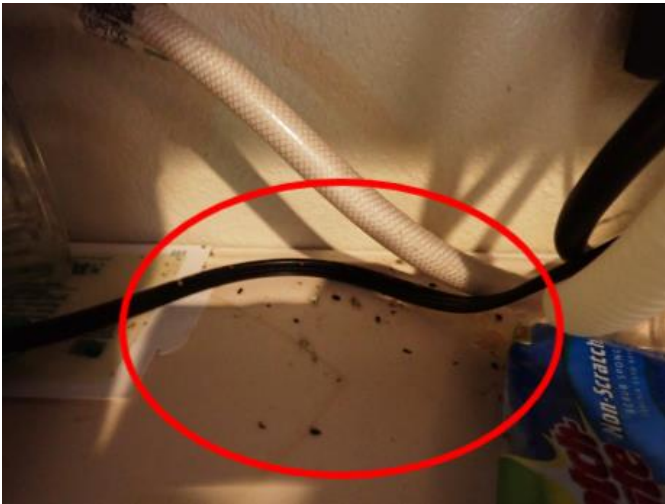
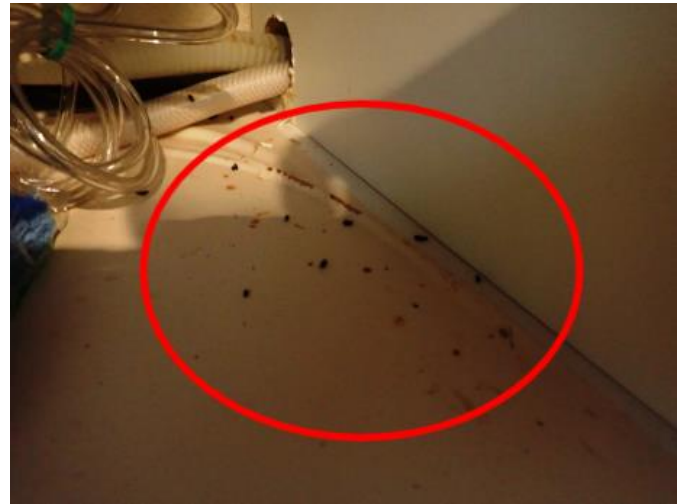
There appeared to be some evidence of possible rodent activity under the kitchen sink and in the pantry. Recommend qualified contractor or proper person evaluate to determine if this is current or past and provide any remediation if needed.

There appears to be mouse droppings under the kitchen sink cabinet

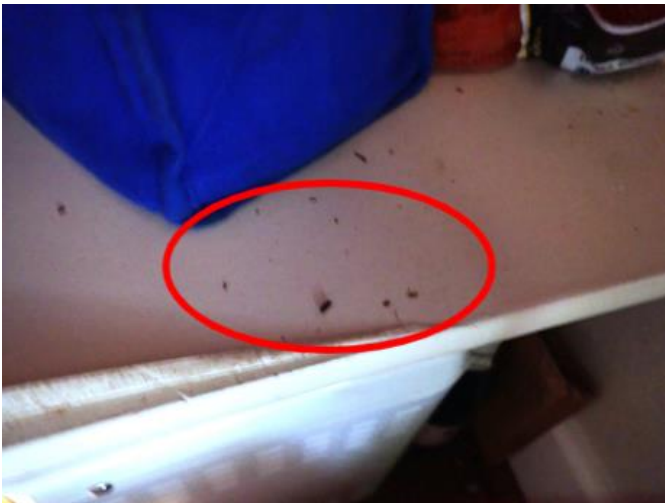
There appears to be mouse droppings on one of the pantry shelves on the right

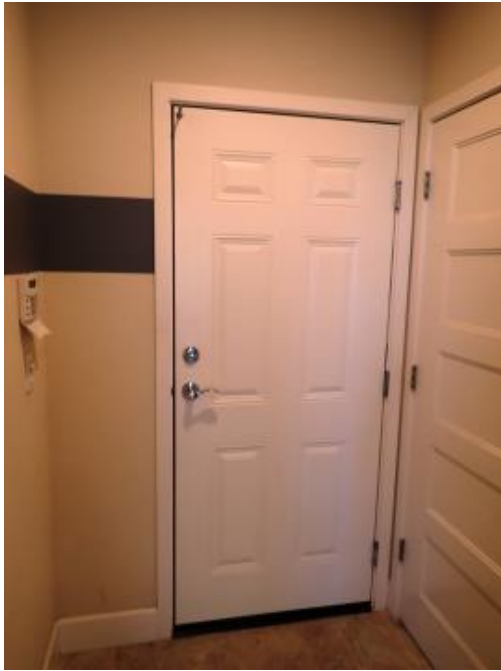
The door to the house tested operable with auto close feature attached and operable

Door from house to garage with auto close hinges in place and operable
